## ----- WARNING -----

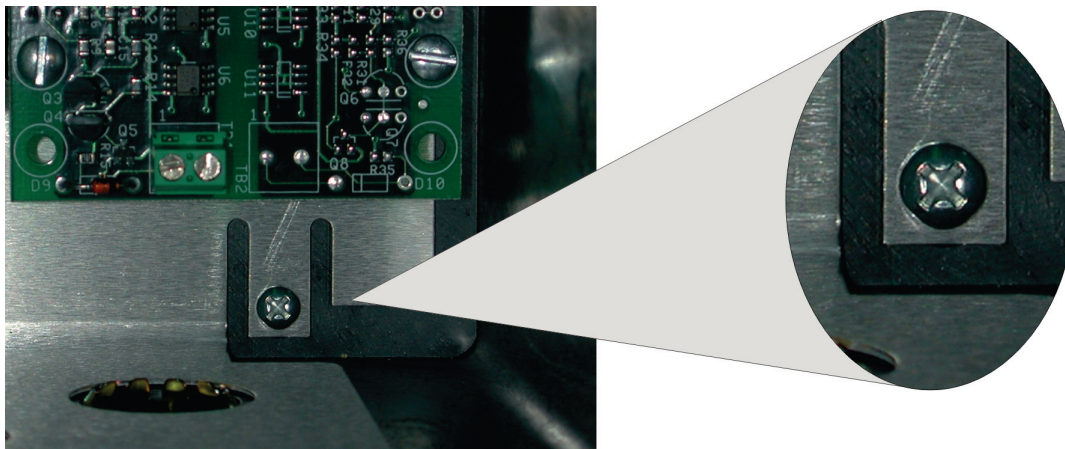
Accessible screw for securing shields to earth ground  
(Located in bottom right corner of recorder)

To ensure proper operation of this equipment, ALL field wiring (sensor, relay output, current output and legal control) shall utilize shielded cable. All shields shall be terminated at the recorder end only, to a common ground screw (see detail below). Be sure that AC power wiring incorporates a proper earth ground within the distribution panel.
